**DRAFT SPRING CREEK BURNED AREA REPORT**  
(Reference FSH 2509.13)

- A. Fire Name: Spring Creek Fire
- B. Fire Number: CO-CTX-001266
- C. State: CO
- D. Counties: Costilla /Huerfano
- E. Region: 2
- F. Forest: Pike-San Isabel
- G. Districts: San Carlos Management Unit
- H. Fire Incident Job Code: PNLW8H
- I. Date Fire Started: June 27, 2018
- J. Date Fire Contained: pending
- K. Suppression Cost: \$20+ million
- L. Fire Suppression Damages Repaired with Suppression Funds
  - 1. Dozerline repaired / waterbarred: 103 out of 137 miles as of 07/5/2018
  - 2. Hand line repaired: 8 out of 14 miles as of 07/15/2018
- M. Watershed Number and Name:

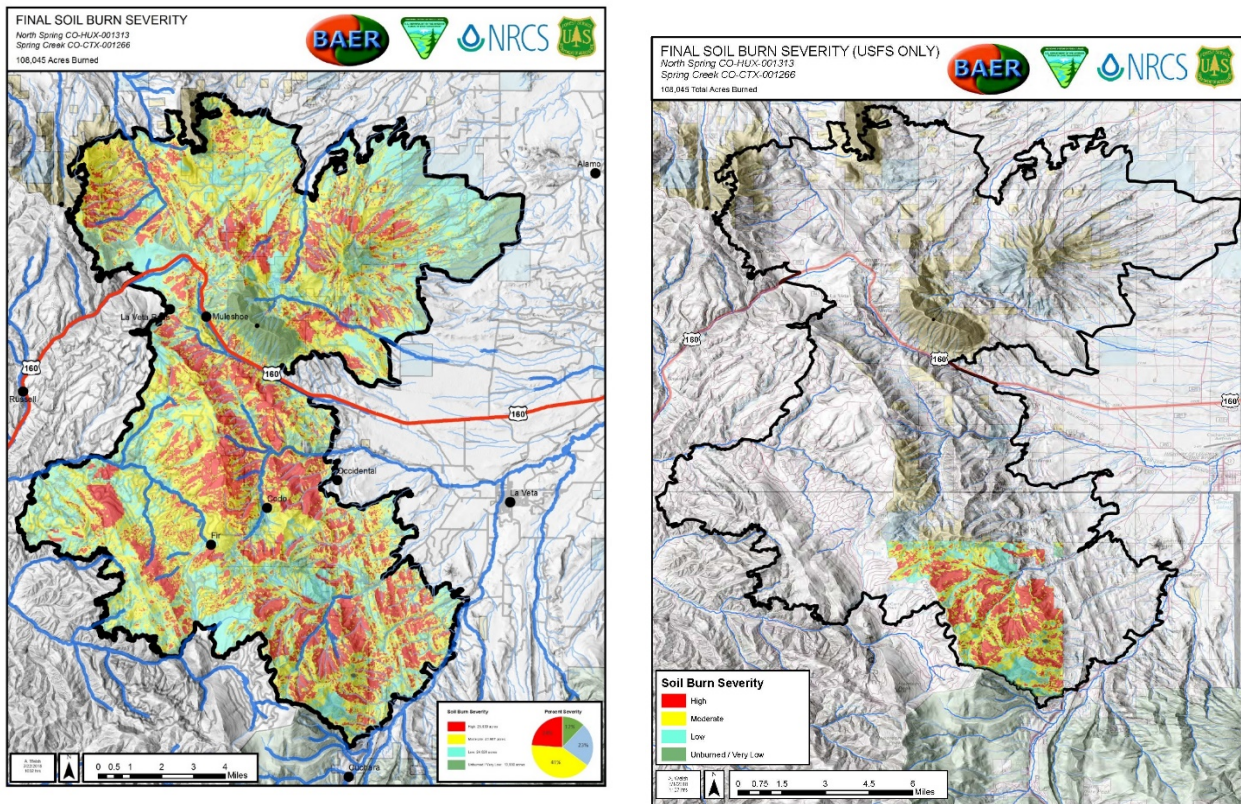
**Map 1: Soil Burn Severity (entire perimeter)**

The Map 1: Soil Burn Severity illustrates the general soil burn severity pattern on the landscape. The soil burn severity is overwhelmingly moderate to high (65%) with the rest being low to very low soil burn severity. There is 23% low soil burn severity because of the high pre-fire ground cover, and partly because the fire was heavily wind-driven.

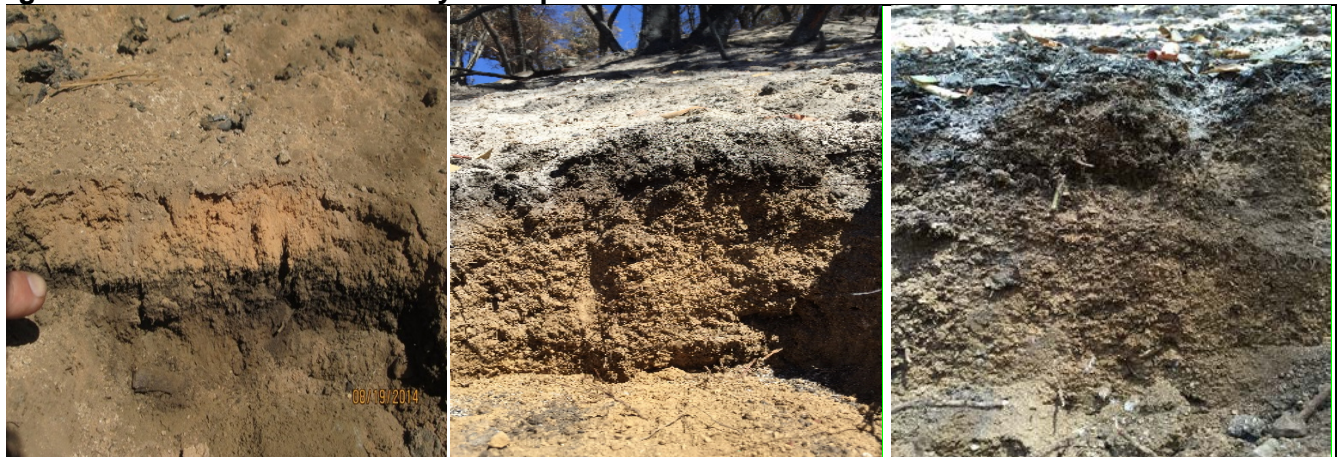
**Figure 2 – Fire Soil Burn Severity Examples**

<p><b>High soil burn severity</b> effects are degradation of surface structure, consumption of soil organic material and formation of water repellent layers</p>	<p><b>Moderate soil burn severity</b> with fire effects of litter and duff removal and char and water repellency to 1 inch below the surface</p>	<p><b>Low soil burn severity</b> due to minimal fire effects on this soil with a clay-loam surface texture</p>
--	--	--

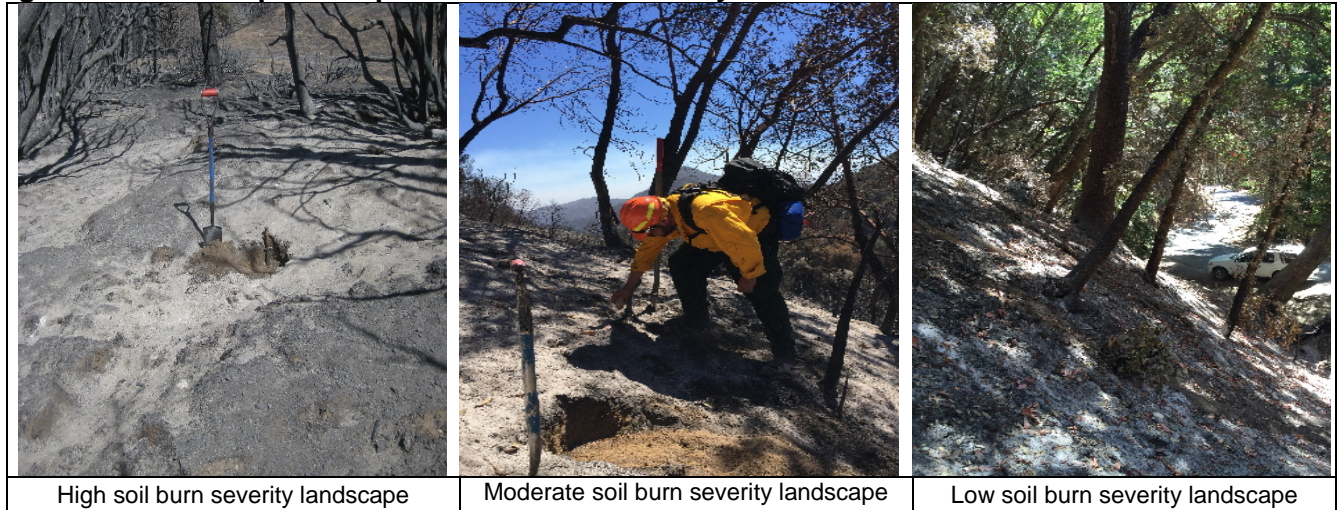
**Figure 3 – Landscape examples for soil burn severity**

The following pictures (Figures 2 & 3) are companion pictures to show typical soil burn severity and landscapes with mixed mortality due to differing vegetation types, slopes, aspect, and location.

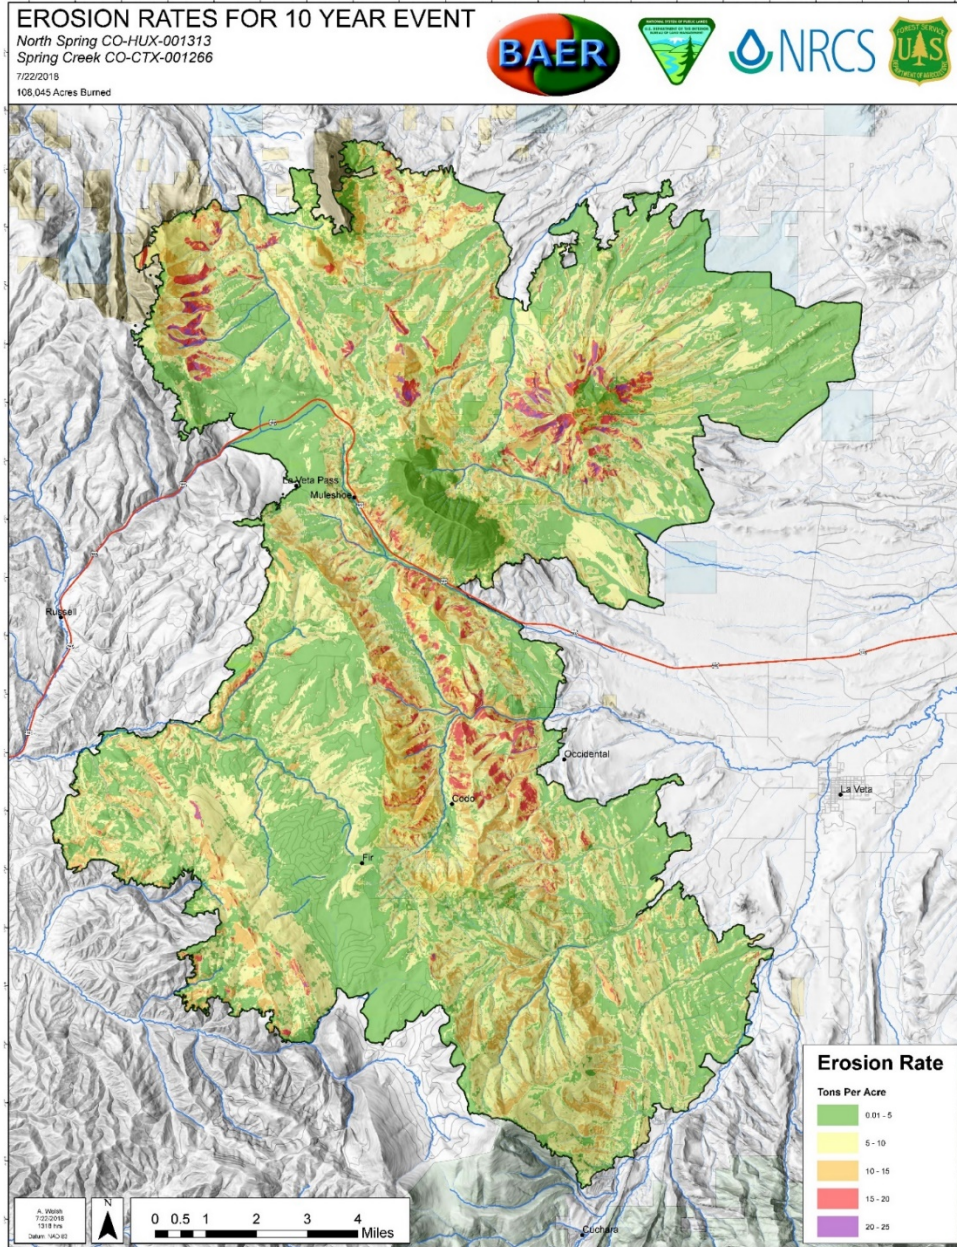
## Map 2: Erosion Rates

Regardless of the accuracy of absolute numbers, the model is used here for relative ratings of different areas within the fire for relative potential as sediment source areas. The headwaters of Indian Creek and Middle Creek have the highest erosion rates, exceeding 6 tons/acre for a 10 year event. These watersheds have a large portion of the area having burned as high. It must be noted that using erosion rates for a watershed should not be used to evaluate the risk at specific areas of a watershed. For instance, Pass Creek watershed had a moderate amount of erosion but also contained the area of greatest risk to flooding and debris flows due to the severely burned steep slopes immediately above

Most watersheds have erosion rates less than 1 ton/acre for a 2-year runoff event. This rate is acceptable with respect to natural recovery versus slope treatments to stabilize soils. This, however, is the average rate for all the watersheds and include unburned areas. Locally, we observed rates much higher following the storms during the assessment. Areas where this occurs shows up (Map E-1 Treatment Map, Appendix E) on very steep slopes where stabilization treatments would not be very effective, and thus not cost effective. Treating lower gradient slopes with lower erosion rates does not reduce total sediment production effectively at watershed scale either and thus is not generally cost effective. Substantial areas in 20-60% slope gradients and high erosion rates are the most cost effective to treat and make a significant difference at watershed scale (see map below).

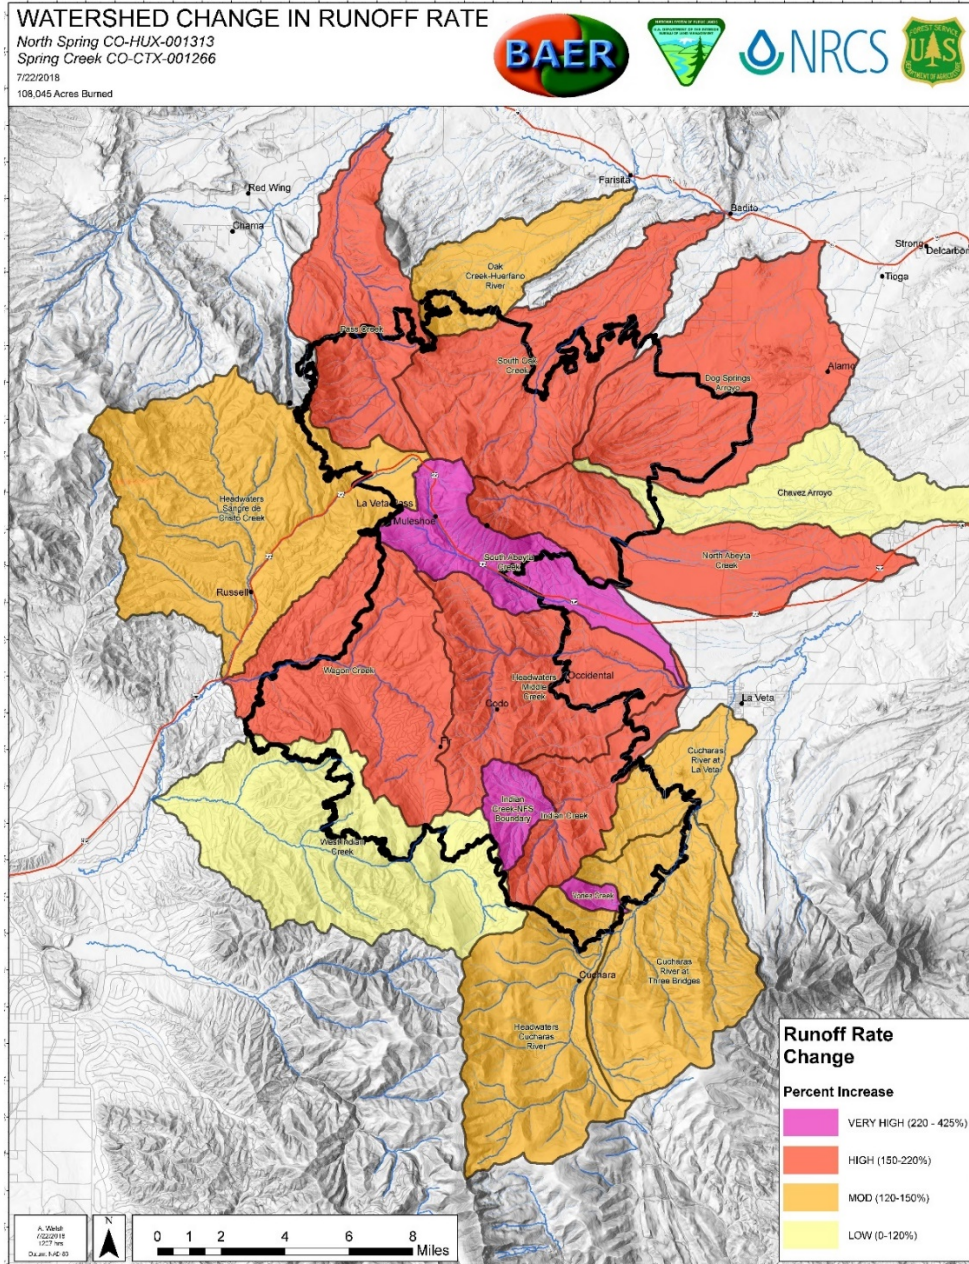
**Map 4: Magnitude of Post-fire Runoff Within the Modeled Watersheds.**

Modeled Watershed	Factor of Increase
North Abeyta Creek	1.5
Oak Creek-Huerfano River	1.3
Pass Creek	2.0
South Abeyta Creek	2.2
South Oak Creek	2.0
Vories Creek	4.25
Wagon Creek	1.5
West Indian Creek	1.1

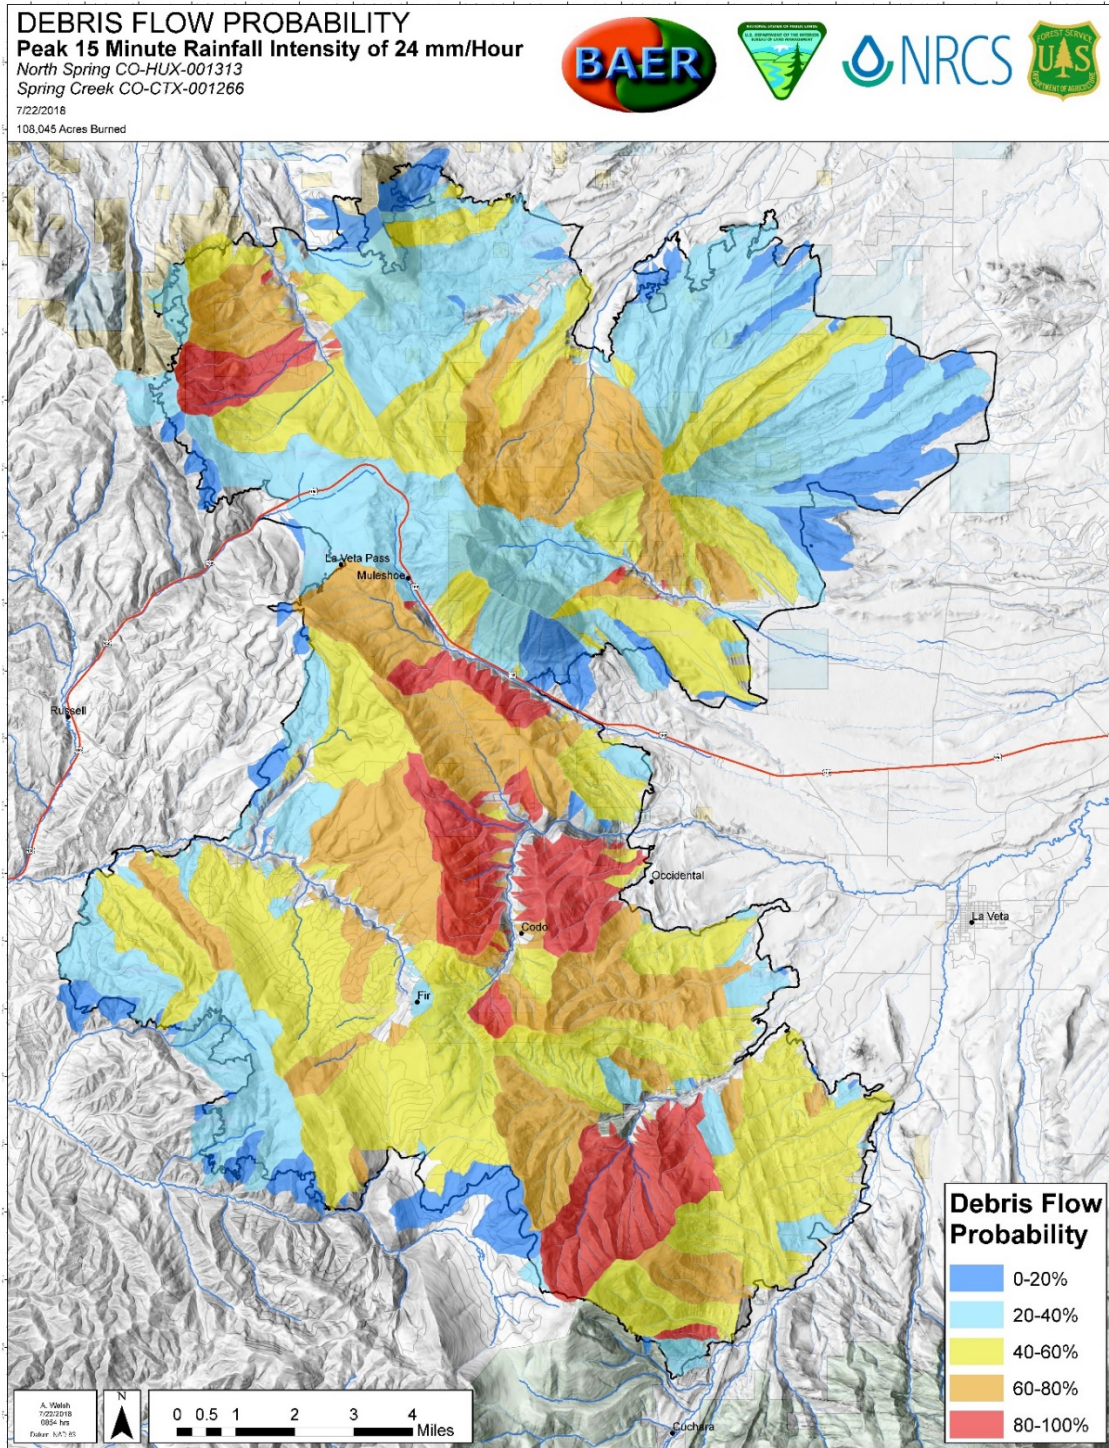
### Map 5: Debris Flow Probability

Based on USGS debris flow modeling it appears that under conditions of a peak 15-minute rainfall intensity storm of 24 millimeters per hour (0.94 inch/hr.), the probability of debris flows occurring is 80-100% in some channel/creeks above Hwy 12, County Road 421, County Road 572 and the community of Paradise Acres. Under these same conditions, predicted volumes of these debris flows are expected to range from 1,000-100,000 m<sup>3</sup> in other channels.

rockfall, debris slides, flooding and sediment deposition, and in some cases, debris flows. Risks to living beings, property and infrastructure, roads, trails, campgrounds, reservoirs and natural resources is moderate to high in some areas of the Spring Creek Fire (see Map 5 below).

Recommended treatments for debris flow, mass wasting and rock fall hazards include coordination with NOAA, OEM, and NRCS to develop an early alert system to notify the public of these hazards before any significant storm. In addition, warning signs and road closures are recommended in some locations in the burn area; clearing and improvement of catch basins and ditches along the road; maintenance and up-grade of drainage structures.
